Manhole Inspection Summary

Manhole # S33W__002MH

Location Address: **rear 1754 clarkson st**

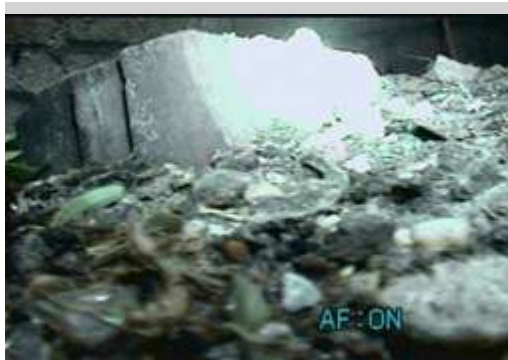
Defect 3

Condition: ☐ Sound ☐ Cracked ☐ Root Intrusion ☐ Deteriorated ☐ Leaks ☒ **Debris**

channel debris

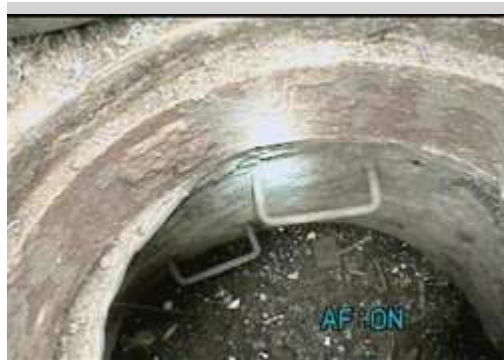
Defect 2

Steps Count: **2** Missing: **0** ☒ **Corroded**

steps

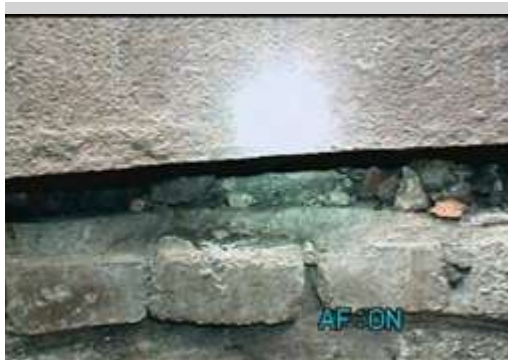
Defect 1

Condition: ☐ Sound ☐ Cracked ☐ Root Intrusion ☒ **Loose Brick** ☒ **Deteriorated**

chimney_cond_loose_bricks,
chimney_cond_deteriorated

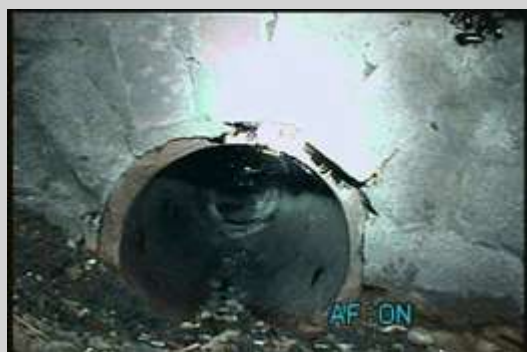
12 O'Clock Outflow

8 in. Circular Gravity Sewer
Pipe Out @ 12 O'Clock

Pipe Material: **Clay** ☐ Pipe Lined

Invert Depth: **5.58** (ft.) Flow Characteristics: **None**

Deposits: ☒ None ☐ Mud ☐ Sludge ☐ Debris ☐ Grease

Infiltration: **None** Pipe Seal Cond: **Unknown**
